Assessment of 2013 Flood Damage to Historic Resources at Blackfoot Crossing
Historical Park: Phase 2

University of Calgary
January, 2017

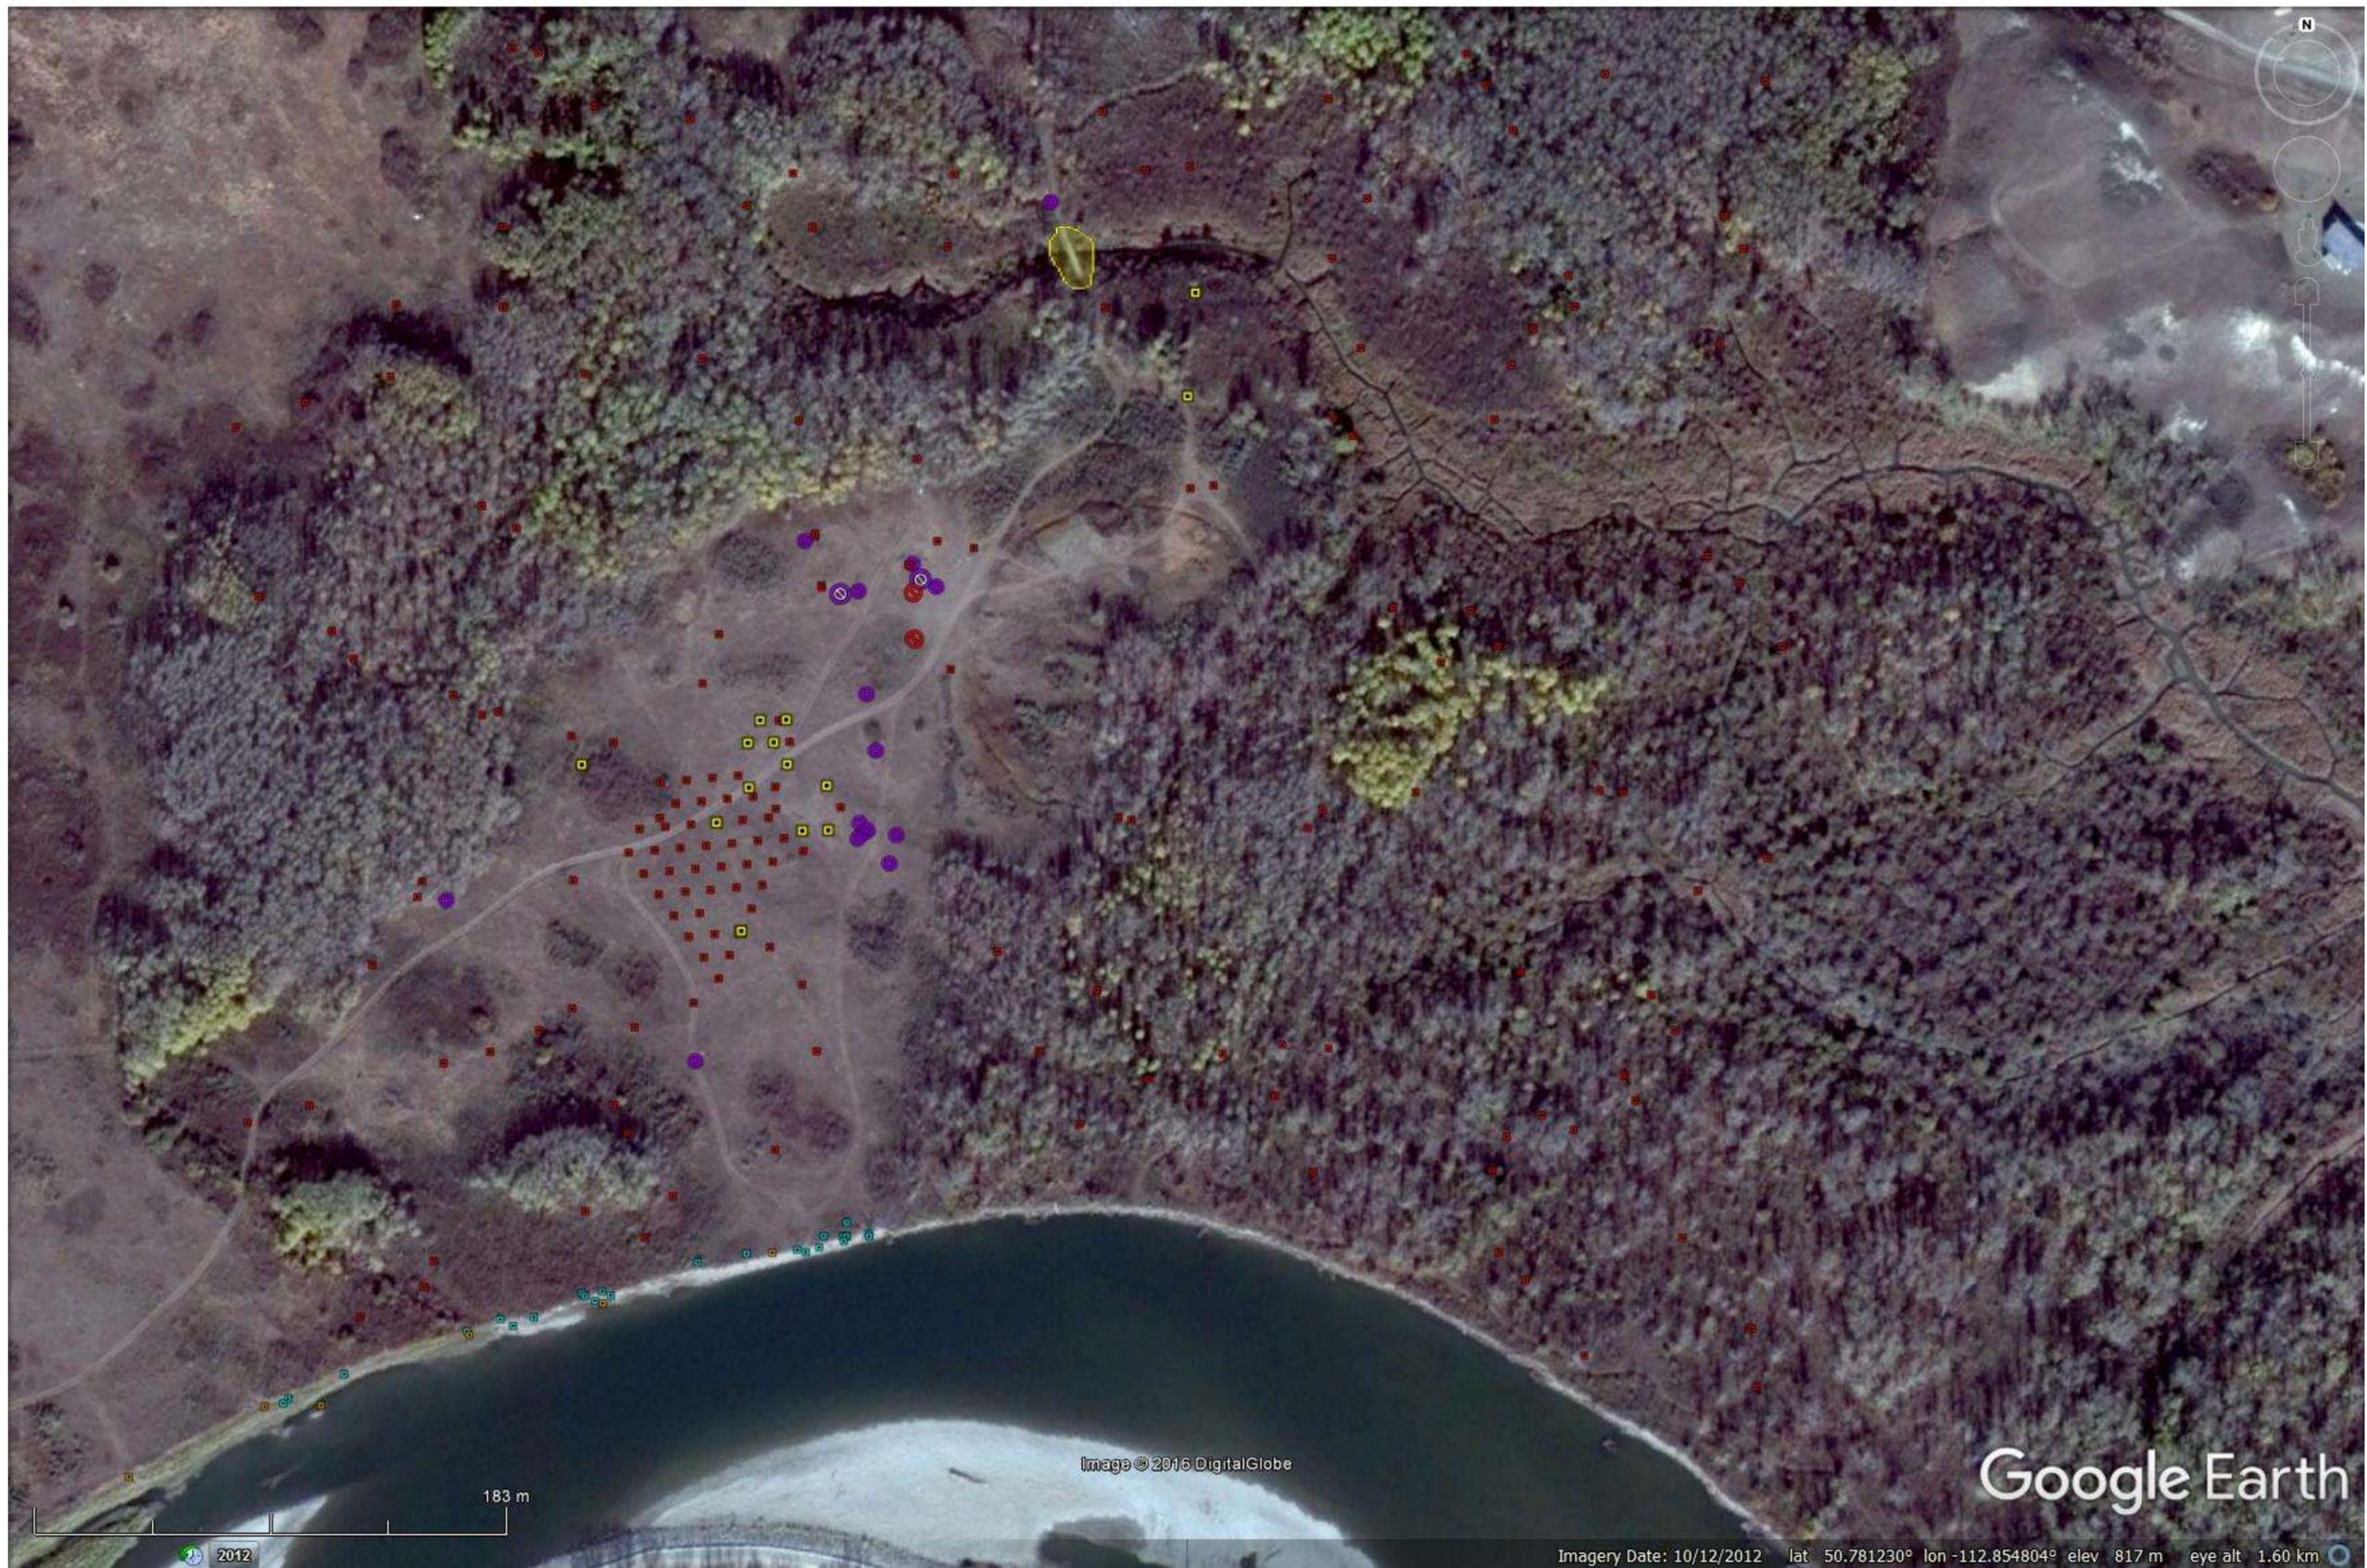
Village Site during the field portion of the Survey class. Two damaged pit features (Forbis Features 16 and 19—easternmost and westernmost damage locations identified on Figure 2), an oil spill (southernmost damage location identified on Figure 2), and a deep heavy equipment tire mark depression (immediately to the southwest of Forbis Feature 16 on Figure 2) were identified in this area by the survey.

Figure 2. 2015–2015 SST and feature and finds locations (North is at the top of the figure). Red symbols represent culturally sterile SST locations, yellow symbols indicate culturally productive SSTs, blue symbols show locations of cutbank features and finds from the Fall 2015 and Spring 2016 survey, while orange symbols display the locations of cutbank finds and features from the Spring 2015 survey. Large purple dots represent the surface features and findspots located during the Spring 2015 survey. Purple dots with enclosed crossed circles represent damaged Forbis pit features 16 and 19, while the red crossed circles represent other construction damage noted during the Fall 2015 survey. The new bridge construction area is outlined in yellow.

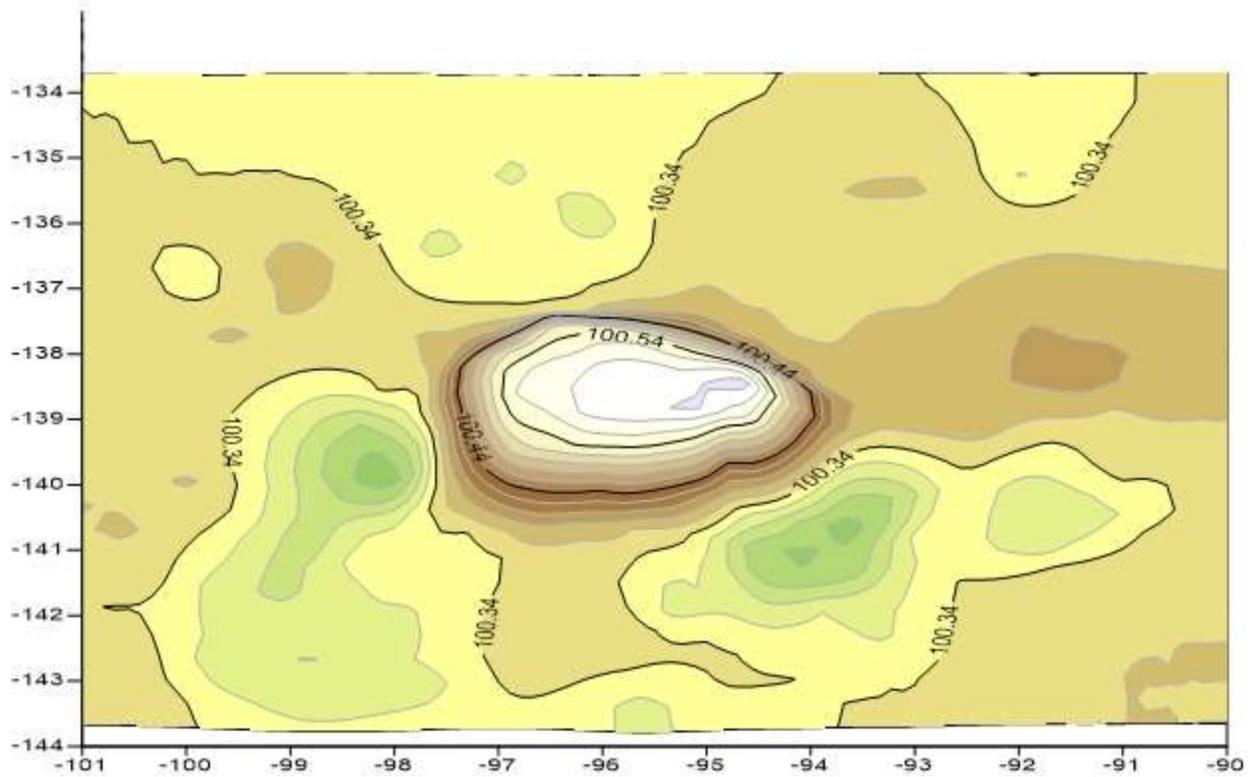
Findspot 2015–009, a small mound located some 164 m southwest of the EePf–1 fortification ditch (Figure 3) was first inspected during the Spring 2015 survey (Walde et al. 2015). That feature was revisited during the Fall 2015 survey and subjected to more detailed measurement including total station survey. The roughly oval shaped mound is about 25 cm high, 3 m long west to east, and 2.5 m wide south to north. The mound appears to have been formed by earth taken from the depressions to its west and southwest.

Figure 3. Three dimensional topographic representation of Findspot 2015–09. The roughly oval shaped mound is about 20 cm high, 3 m long west to east, and 2.5 m wide south to north. The mound appears to have been formed by earth taken from the depressions to its west and southwest.

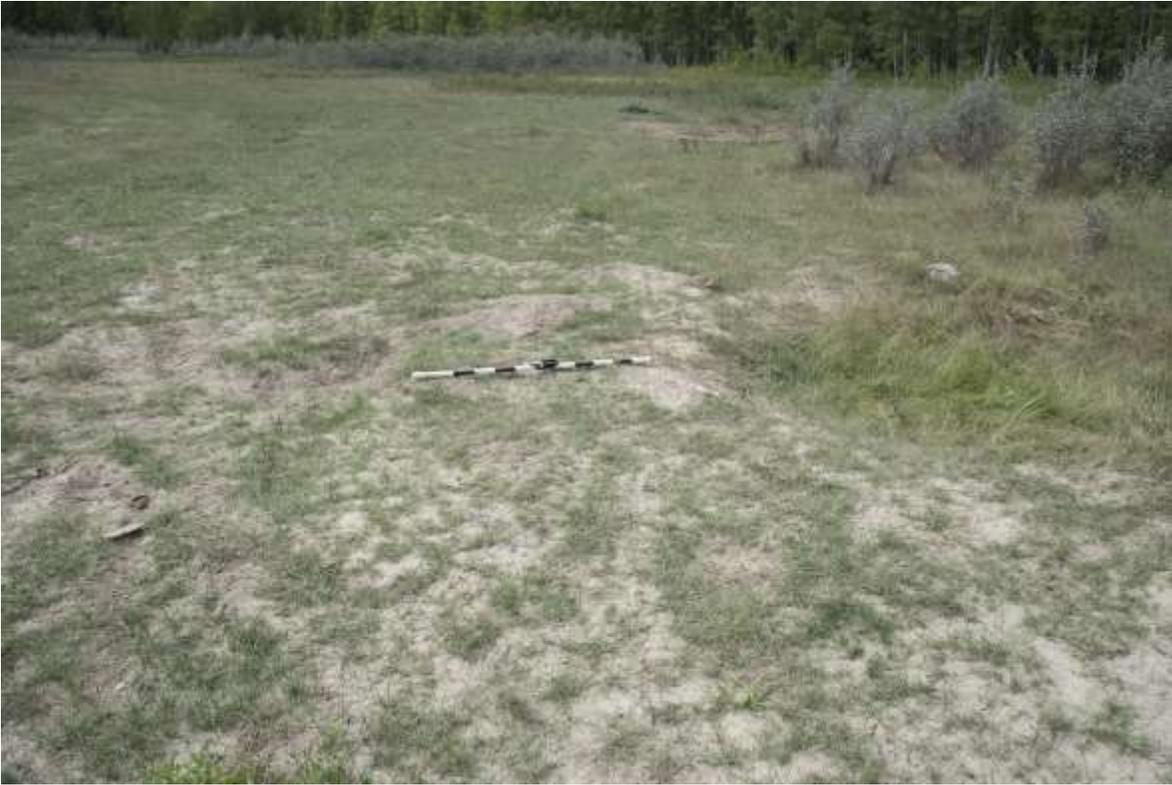
The second damaged pit is Forbis Feature 19. This pit is 2.15 meters east to west, and 2.36 meters north to south. Heavy equipment tire tread marks have cut into the pit on the east portion of the wall (Plate 1)), and the west portion of the wall was partially collapsed. This pit is associated with an earthen mound 4m to the east centre to centre (Findspot 13, Walde et al 2015). The mound measures 2.69 meters east to west and 2.91 meters north to south. This mound was visibly driven over by heavy equipment as its contour changed from its original configuration noted during the Spring Archaeological Field School 2015 and from previous observations at the site. The ground was likely wet when this damage was done given the pressure needed for the depth of the tire treads. Construction vehicles likely caused this damage during the 2015 summer bridge construction project.

Plate 1. Vehicle damage to Forbis Feature 19.

- Policies should be put in place to protect the fragile cultural and natural resources of BHP. Specifically, vehicular traffic should be tightly controlled and restricted. Vehicular traffic should be banned completely during and following wet weather. The vehicle trail through the fortifications should be closed.

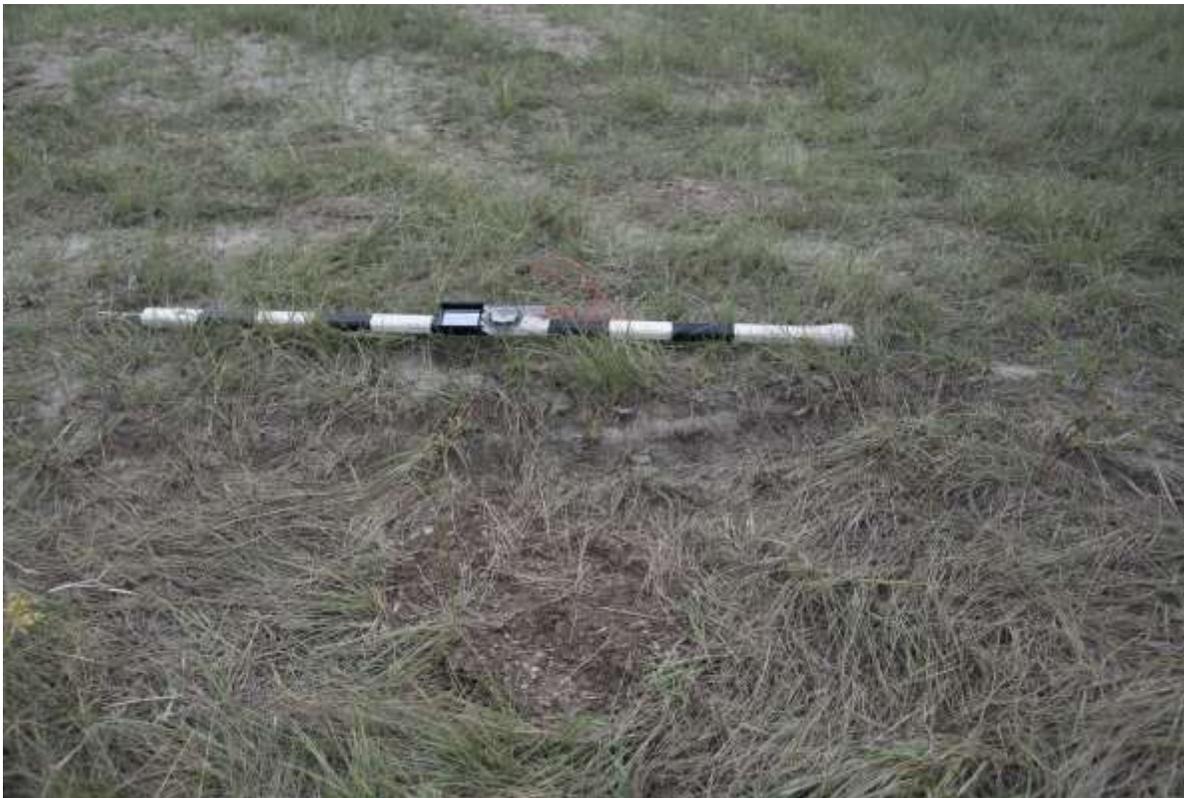
One pit feature damaged by heavy equipment traffic, likely during the 2015 late summer bridge construction activities is Forbis Feature 16 (Forbis 1977). The pit walls that once were slightly raised are now flat and tire tread marks are visible (Plate 2). This damaged pit is located near a deep heavy equipment tire impression located 1.5m to the north of the pit. None of this damage was present when the feature was inspected during the initial flood damage survey conducted during the spring of 2015 (Walde et al. 2015).

Plate 2. Close view of damage to Forbis Feature 16.

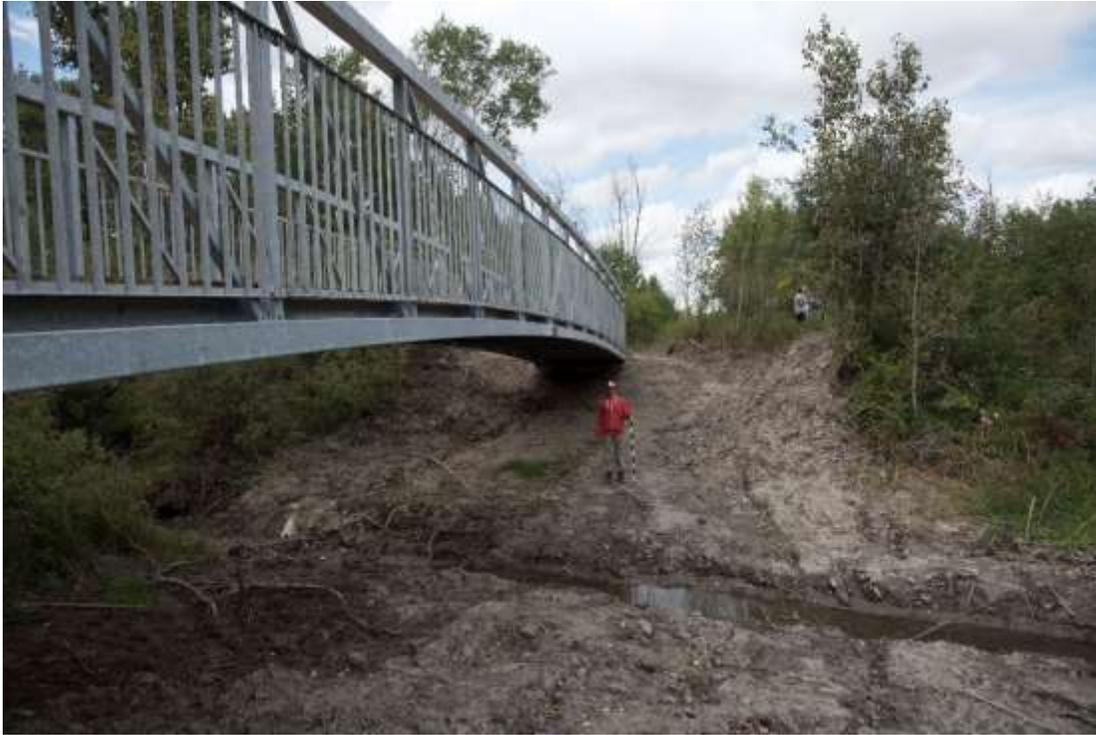
The newly installed footbridge and its surrounding area were also surveyed for damage (outlined in yellow on Figure 2). Photographs were taken of the construction area around the new bridge (Plate 3). The recovery of bone fragments in the excavated area may suggest that historic resources were destroyed during construction. The historic dump (Walde et al. 2015) along the path to the north of the bridge was reassessed and recorded (Figure 2, Plate 4).

Plate 3. Footbridge construction damage to oxbow looking north. The historic dump site is immediately north of the bridge.

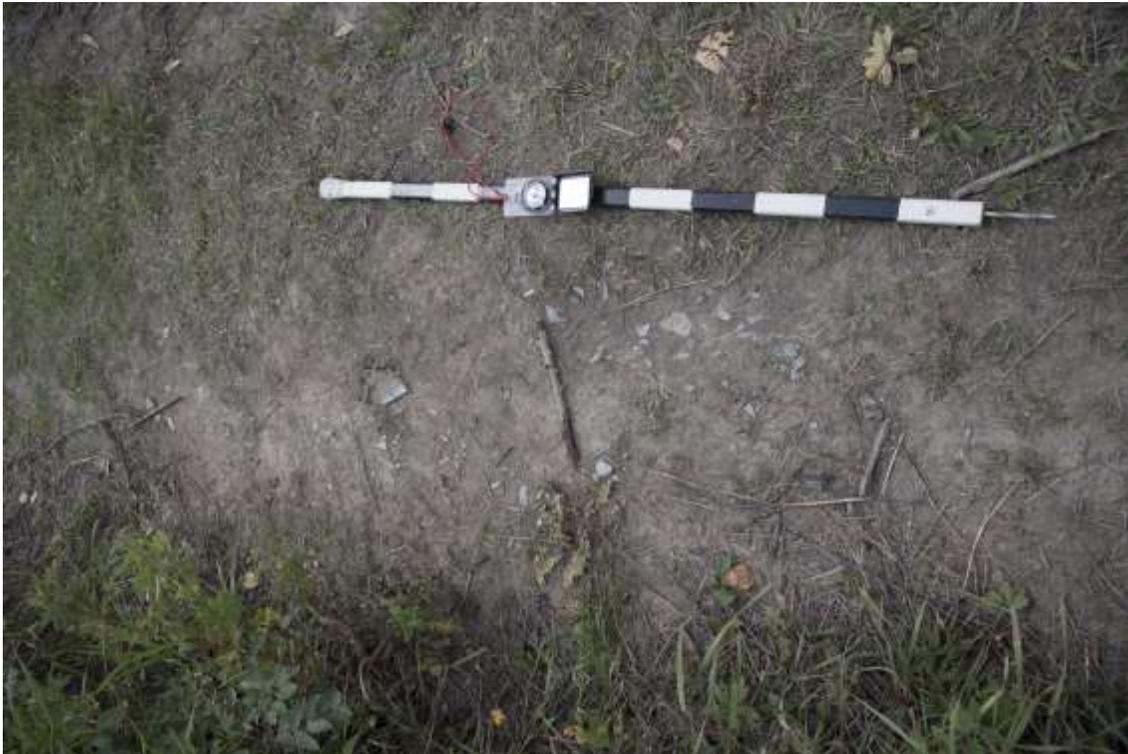
Plate 4. Historic dump detail.

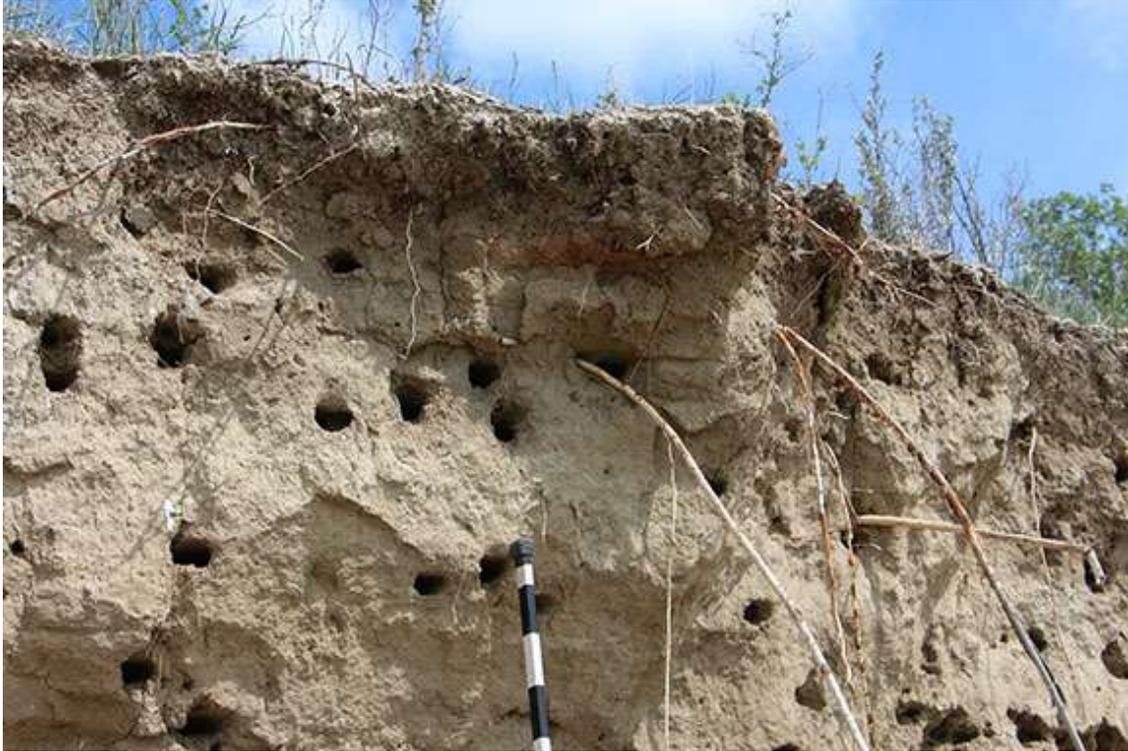
The hearth at Findspot 201606-002 was 5 cm thick and located at its base some 35 cm below the present surface (Plate 5).

Plate 5. Hearth in cutbank (201606-002).

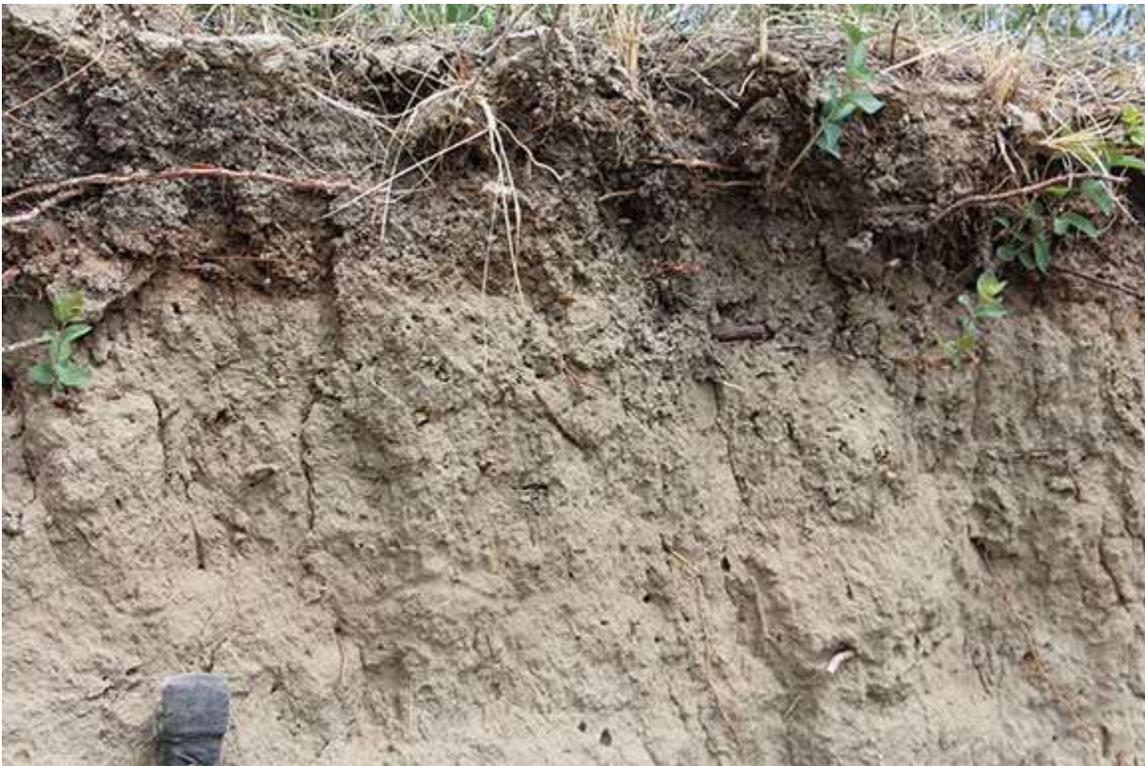
The hearth at Findspot 201606-006 was 3 cm thick and located at its base some 12 cm below the present surface (Plate 6).

Plate 6. Hearth in cutbank (201606-006).

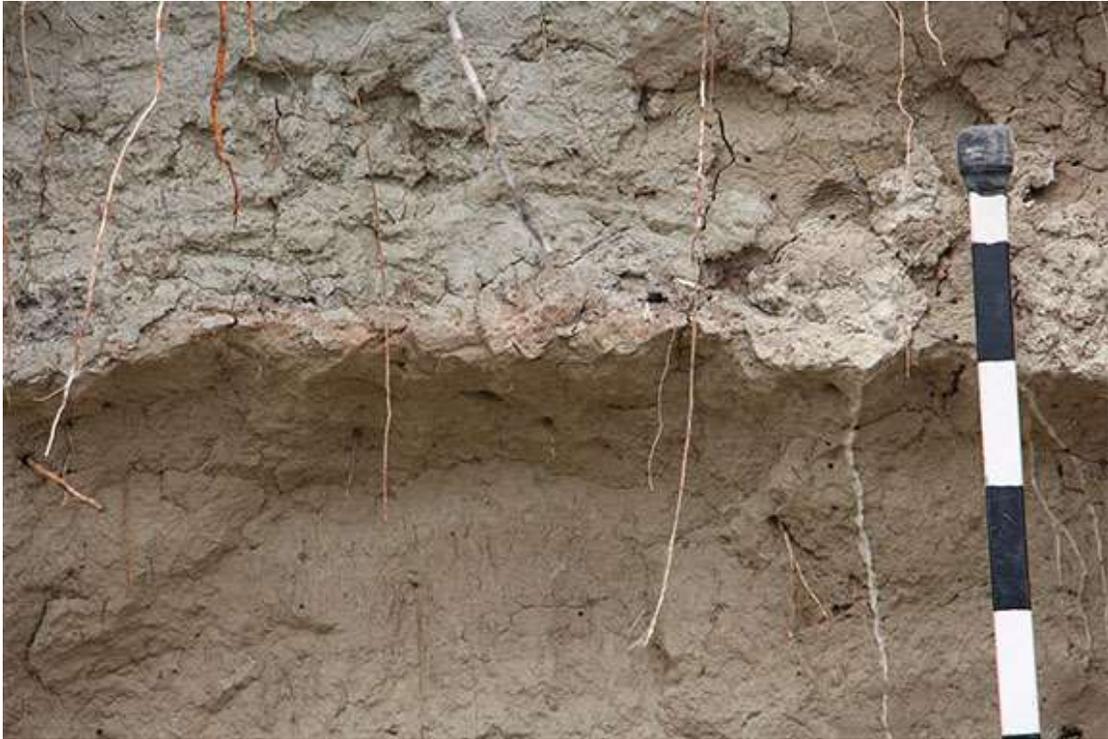
The hearth at Findspot 201606-019 was located 1.2 m below the present surface. The hearth feature was found immediately above a recent slump and was partially removed by that slump (Plate 7). A small fragment of mammal bone was noted in the hearth.

Plate 7. Hearth in cutbank (201606-019). Note bone fragment in upper right corner of the hearth.

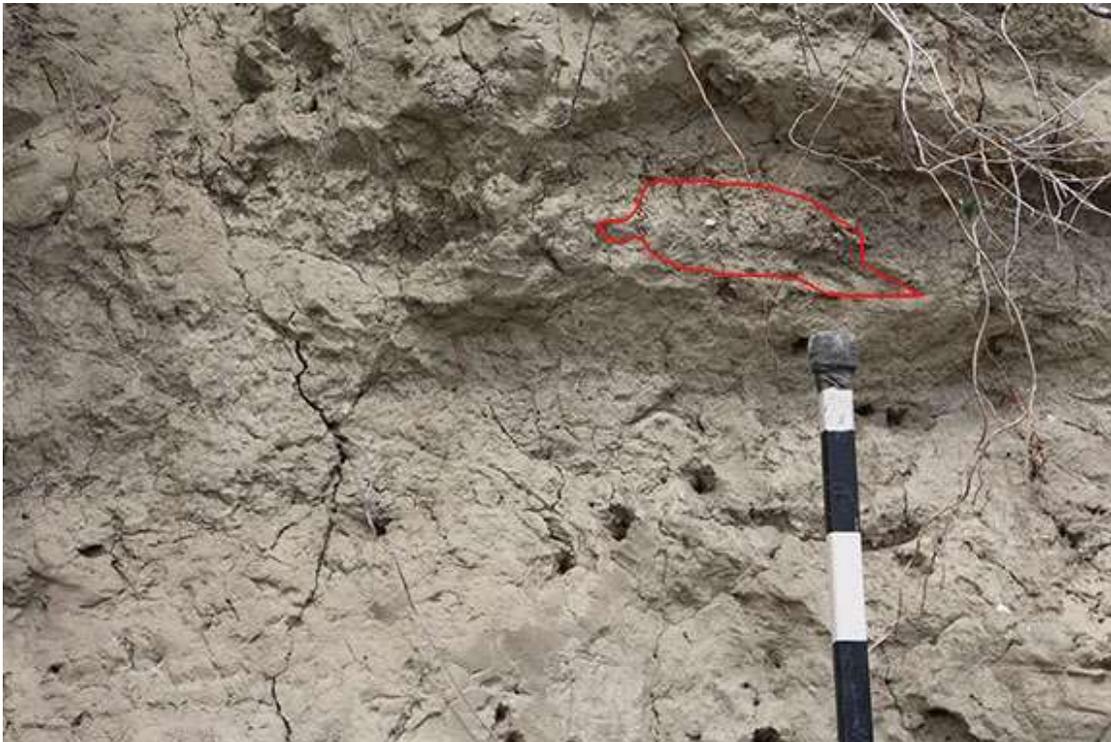
A 15 cm thick ash lens (Findspot 201606-022; 12 U 368985.10 5626938.3) was discovered at a basal depth of 1.17 m. A fragment of mammalian bone was noted in that deposit (Plate 8).

Plate 8. A 15 cm thick ash lens (201606-022) 1.17 cm below surface. A fragment of mammalian bone was noted in that deposit.

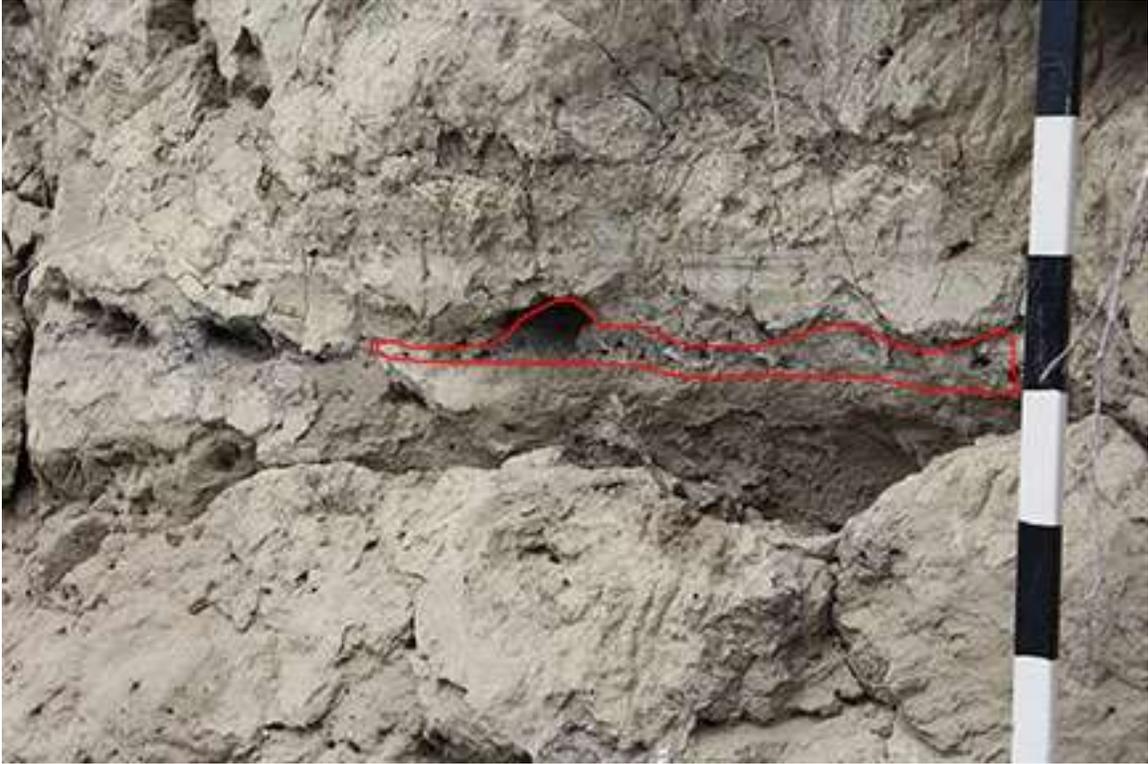
A 15 cm thick ash lens (Findspot 201606-023; 12 U 368972.20 5626937.70) was discovered at a basal depth of 1.05 m. A fragment of mammalian bone was noted in that deposit (Plate 9).

Plate 9. A 15 cm thick ash lens (201606-023) 1.05 m below surface.

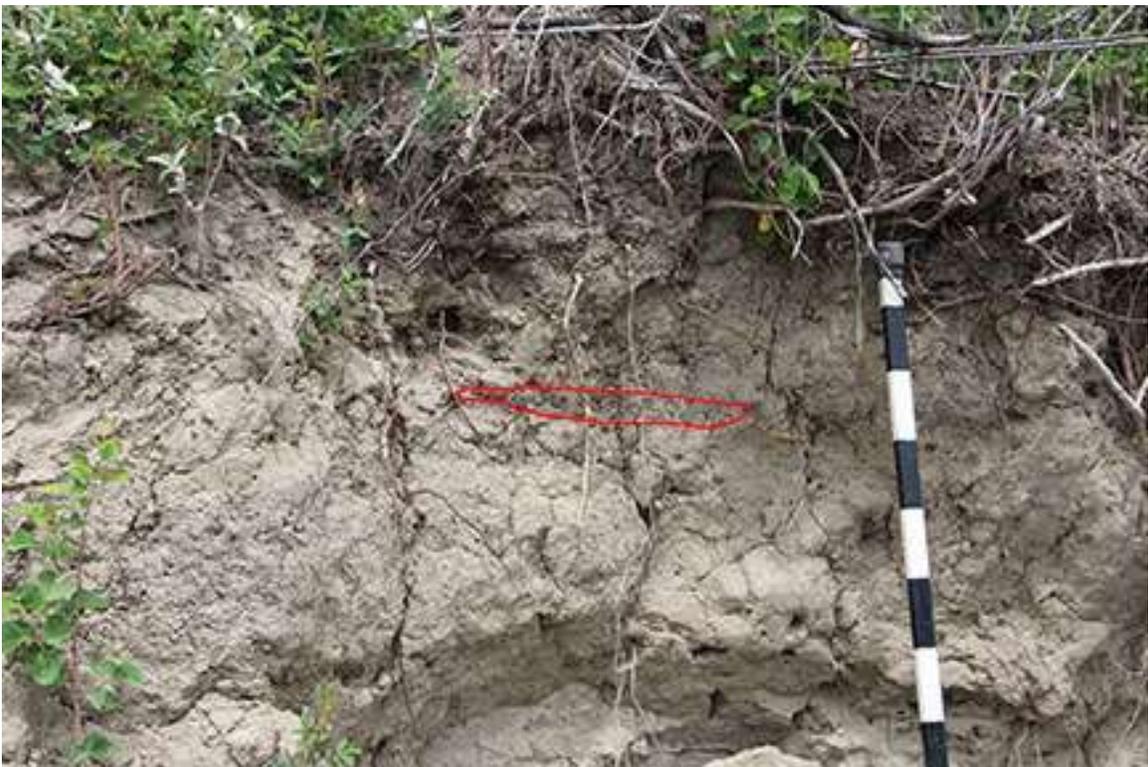
A 10 cm thick ash lens (Findspot 201606-26. 12U 368887.20 5626907.00) was found at its base some 60 cm below the present surface (Plate 10).

Plate 10. A 10 cm thick ash lens (201606-26) 60 cm below surface.

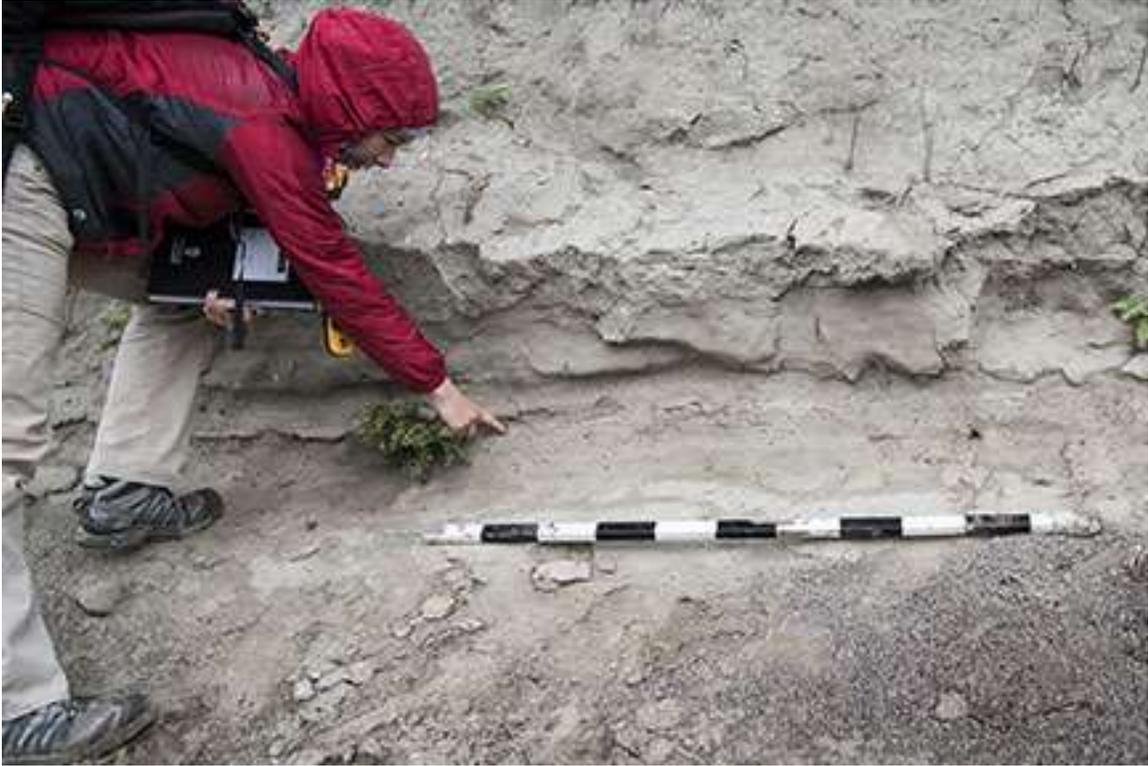
A thin white sedimentary deposit (Feature 201509–003), approximately 0.5 centimeters thick, was identified at UTM: 0368998 5626937, 1.8 meters below the surface on the cutbank face. This thin white deposit continues for 2.2 meters to the North East (Plate 11).

Plate 11. A thin white sedimentary deposit (201509-003) 1.8 meters below the surface on the cutbank face. This thin white deposit continues for 2.2 meters to the northeast.

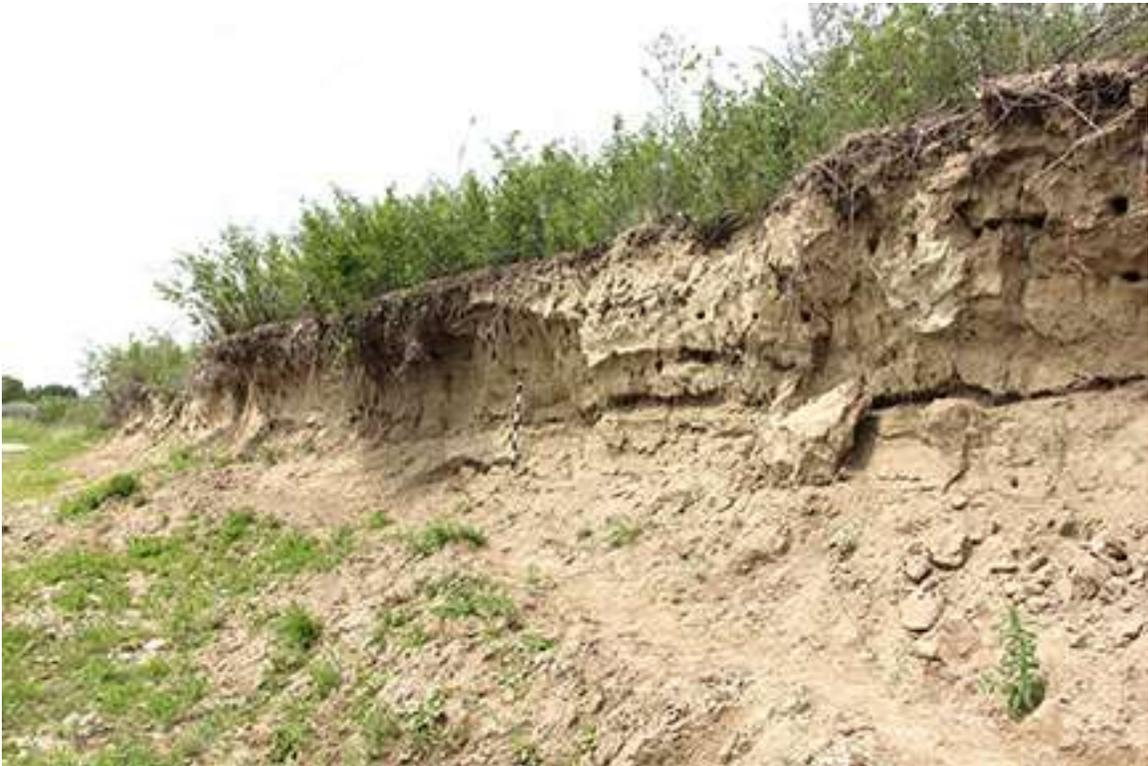
While many cultural resources in the park are very shallowly buried others are located at some depth. The results of the cutbank survey reveal the presence of deeply buried cultural and palaeontological resources (see also Walde 2008 and Walde et al. 2015). The full vertical and horizontal extents of these resources remain to be explored but those resources located in proximity to the Bow River are at hazard from ongoing cutbank erosion (Plate 12).

Plate 12. Ongoing cutbank erosion at BHP.

- Loss of cultural materials, including deeply buried features, to cutbank erosion is ongoing. Deep testing and salvage excavations should be conducted to assess the nature of cultural deposits in that area.
