Assessment of 2013 Flood Damage to Historic Resources
at Blackfoot Crossing Historical Park: Phase 1

University of Calgary
July, 2015

Executive Summary

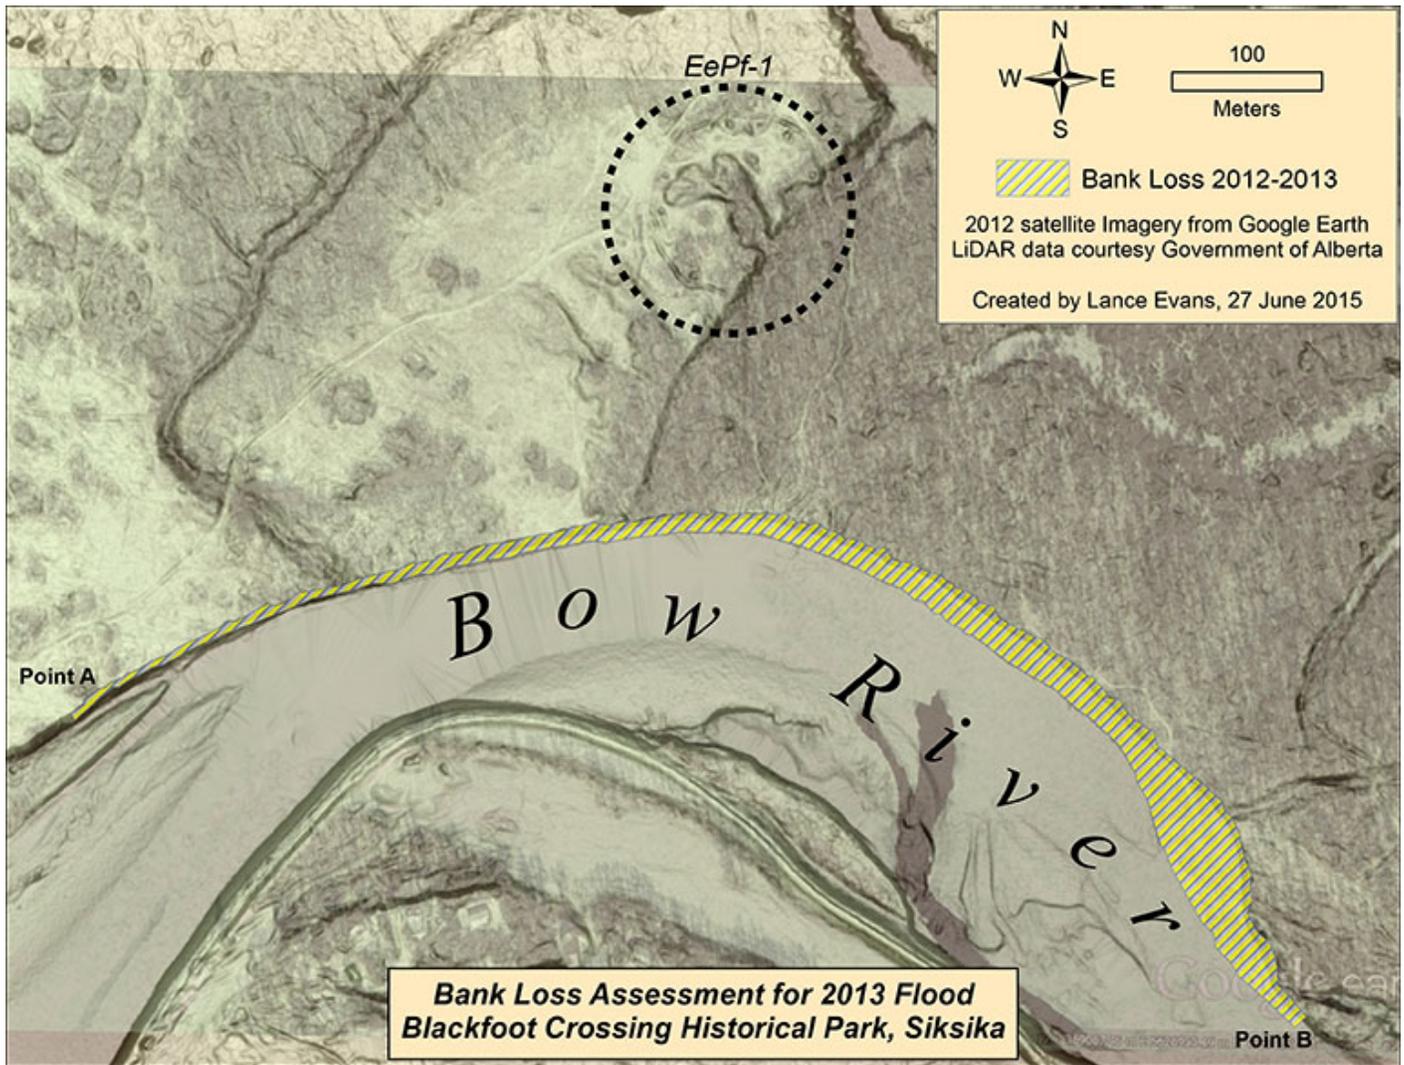
Figure 1. Bank loss in BCHP between 2012 and 2013.

Approximately 1.7 hectares of BCHP property was lost during the 2013 flood due to north cutbank erosion. Erosion of the north cutbank here is active and ongoing, representing a continuing threat to historic resources within the park.

We estimate a total loss of 1.7 ha of BCHP property along the north bank of the Bow River between Point A (12U 368772 5626842) and Point B (12U 369597 5626644).

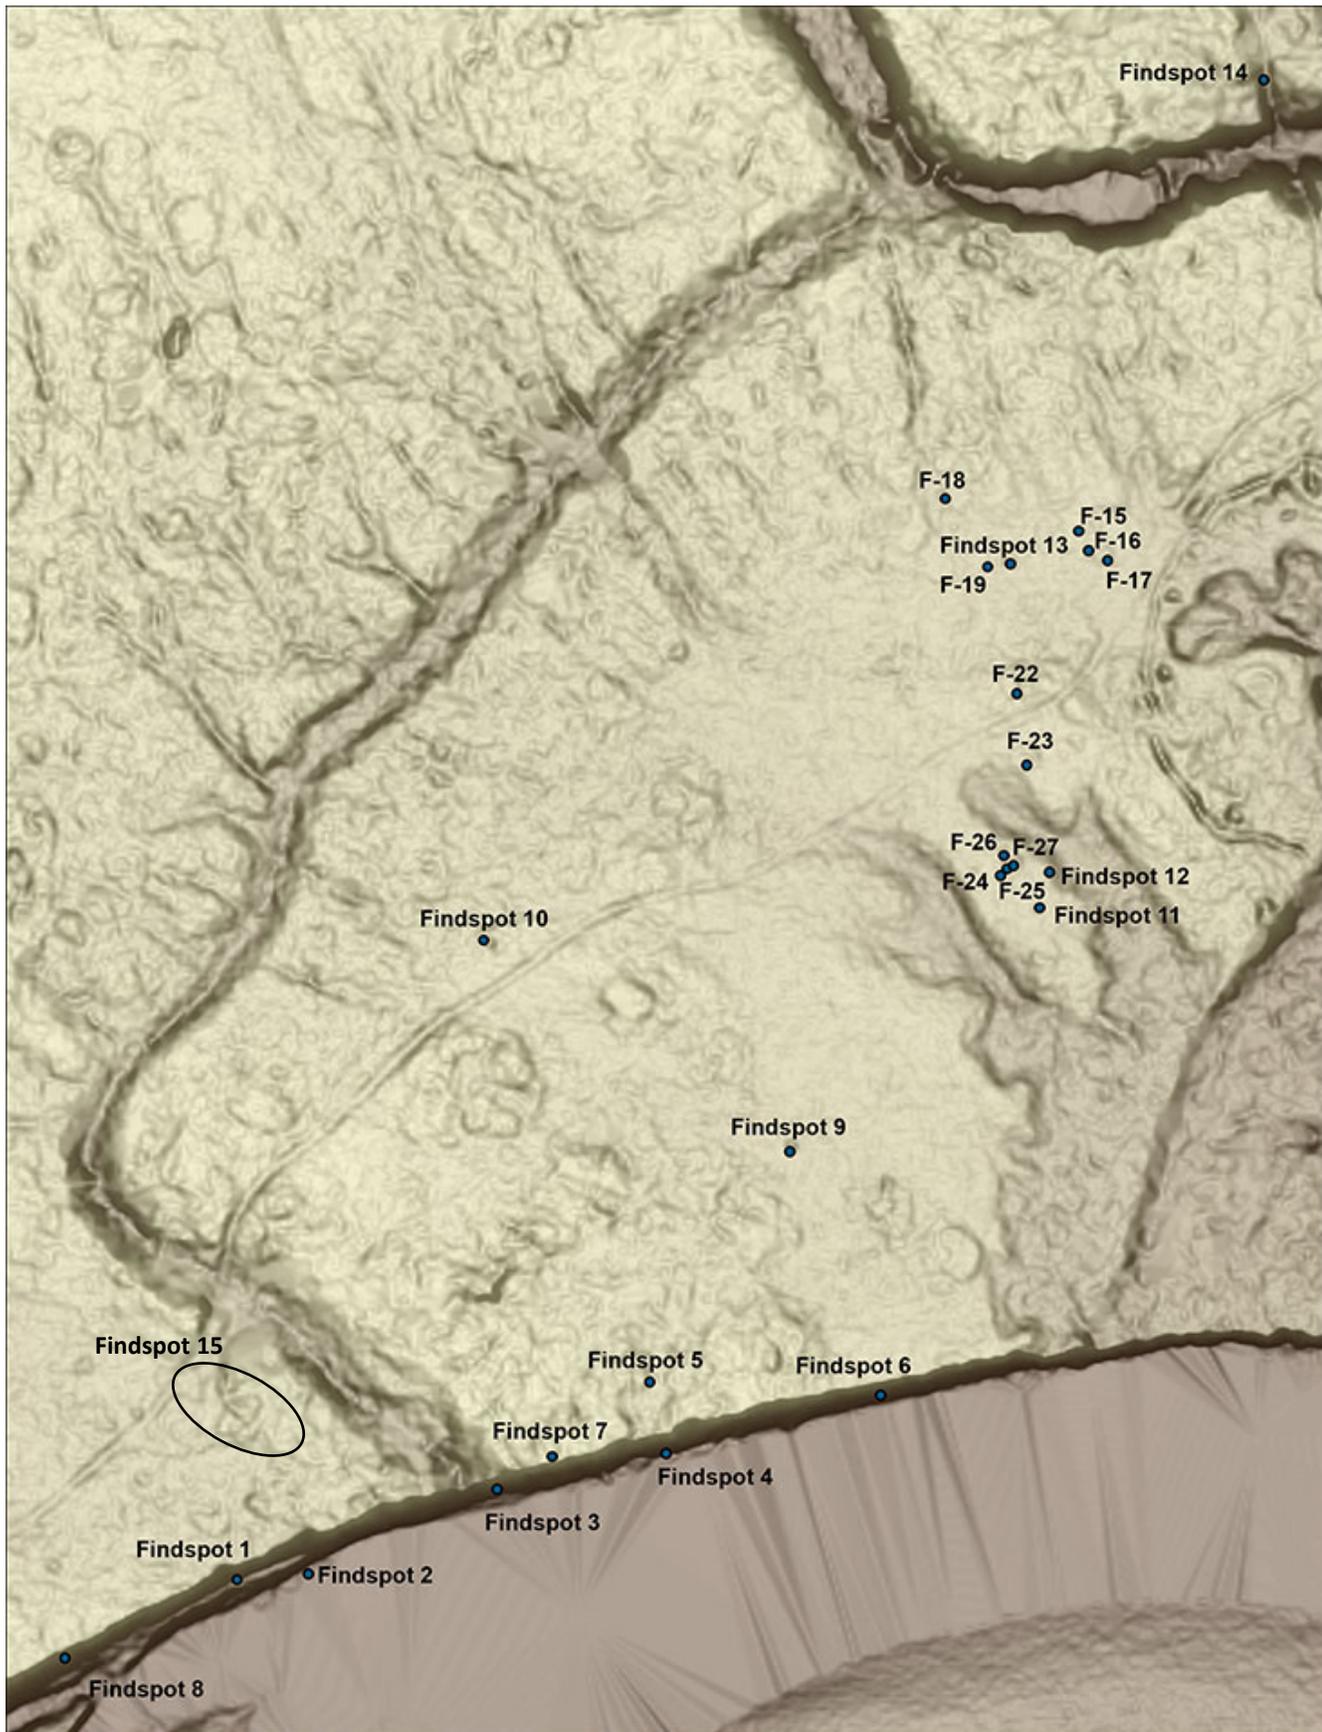
Figure 2. All findspots and features noted during Phase 1 of the 2015 University of Calgary flood damage assessment survey.

A total of 15 new findspots within the confines of Blackfoot Crossing Historical Park (Figure 2). Of these, eight are located along the present actively eroding cutbank of the Bow River. Seven of the resources are located on the flood plain of BCHIP and were not negatively impacted by the flood although they were further covered by about eight cm of silt.

We recommend further deep testing along the river boundary of BCHP to assess the nature of the remaining resources there. Mitigative excavation of any significant resources in that area should be conducted to lessen the impact of further erosion.

The newly noted features on the BCHP floodplain should be subjected to subsurface testing to assess their significance. These features should be monitored on an ongoing basis.

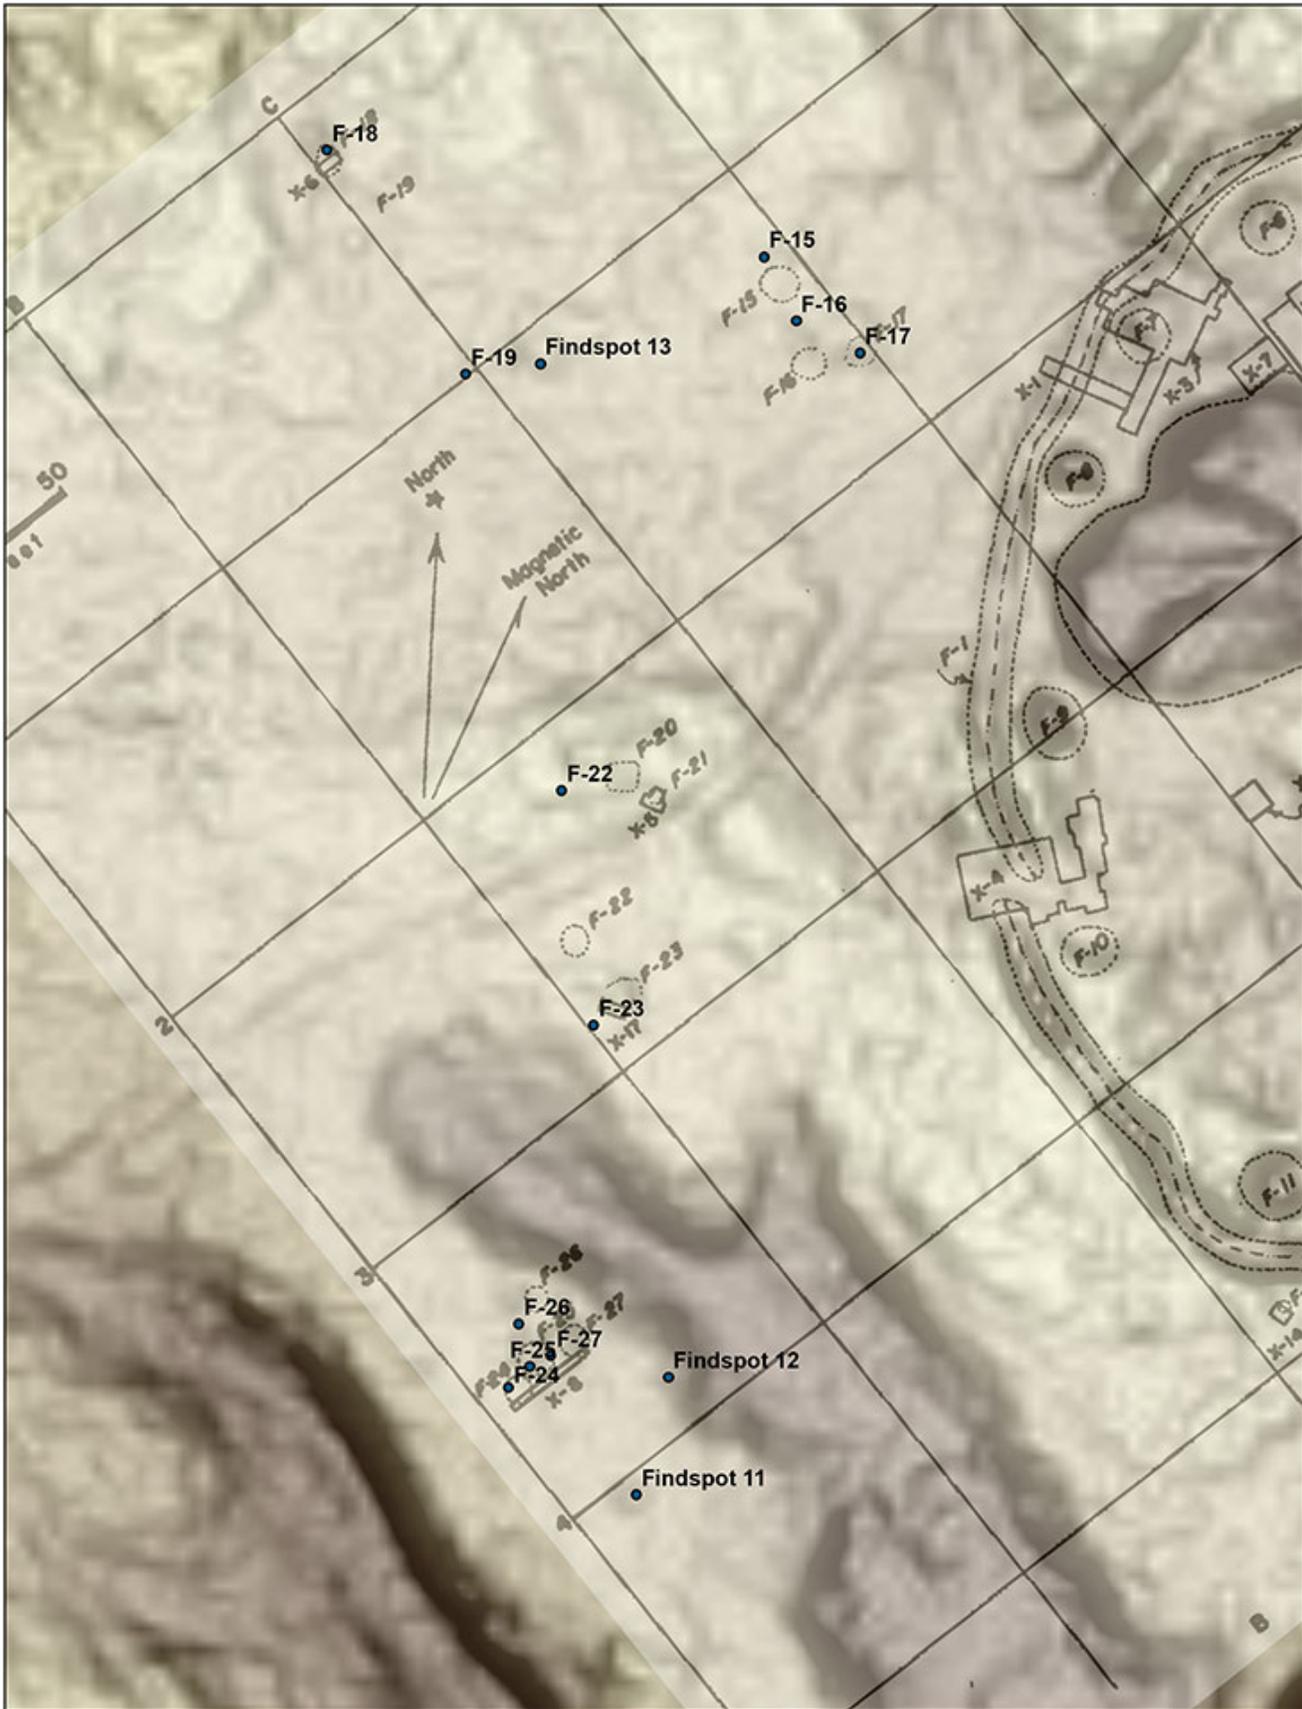
Figure 3. Relationship between Forbis's mapped locations of features and those recorded during the 2015 University of Calgary survey.

Forbis's Features 15–19 and 22–27 (1977: Figure 4 and p. 32) were relocated. Forbis's Features 20 and 21 could not be located in dense brush that could not be cleared under the present mandate. Three additional pits and two mounds were encountered and noted as findspots.

The 2015 hand-held GPS locations for F-15, F-16, F-17 coincide with reasonably well surface disturbances in the LiDAR data and with the Forbis map, although F-15 and F-16 are both offset to the northwest from their locations on the Forbis map.

The GPS location of F-18 coincides with a prominent surface depression in the LiDAR data and with its location as marked the Forbis map.

The GPS point for F-19 is located over 18 m away from the F-19 label on the Forbis map but is adjacent to a small mound in the LiDAR data. This could be due to GPS error, an

error in the Forbis map, or a mistaken identification during 2015 of a feature not noted by Forbis compounded by a failure to relocate Forbis's Feature 19.

GPS point F-22 is located over 14 m away from the F-22 drawn on Forbis map and is located near F-20 on Forbis map. This could be due to GPS error or a mistaken identification of Feature 20 as F-22 compounded by a failure to relocate Feature 22.

GPS point F-23 coincides with F-23 on the Forbis map and is adjacent to both a small rise and a small depression in the LiDAR data.

GPS points F-24, 25, 26, and 27 appear to coincide with their locations on the Forbis map and with a series of shallow pits and mounds in the LiDAR data.

We recommend using a differential GPS system and more intensive survey to relocate the features recorded by Forbis outside the fortifications. While most of the hand-held locations recorded during the 2015 survey coincide reasonably well with those indicated by Forbis, others do not. Future historical resource management efforts require accurate relocation of these features.

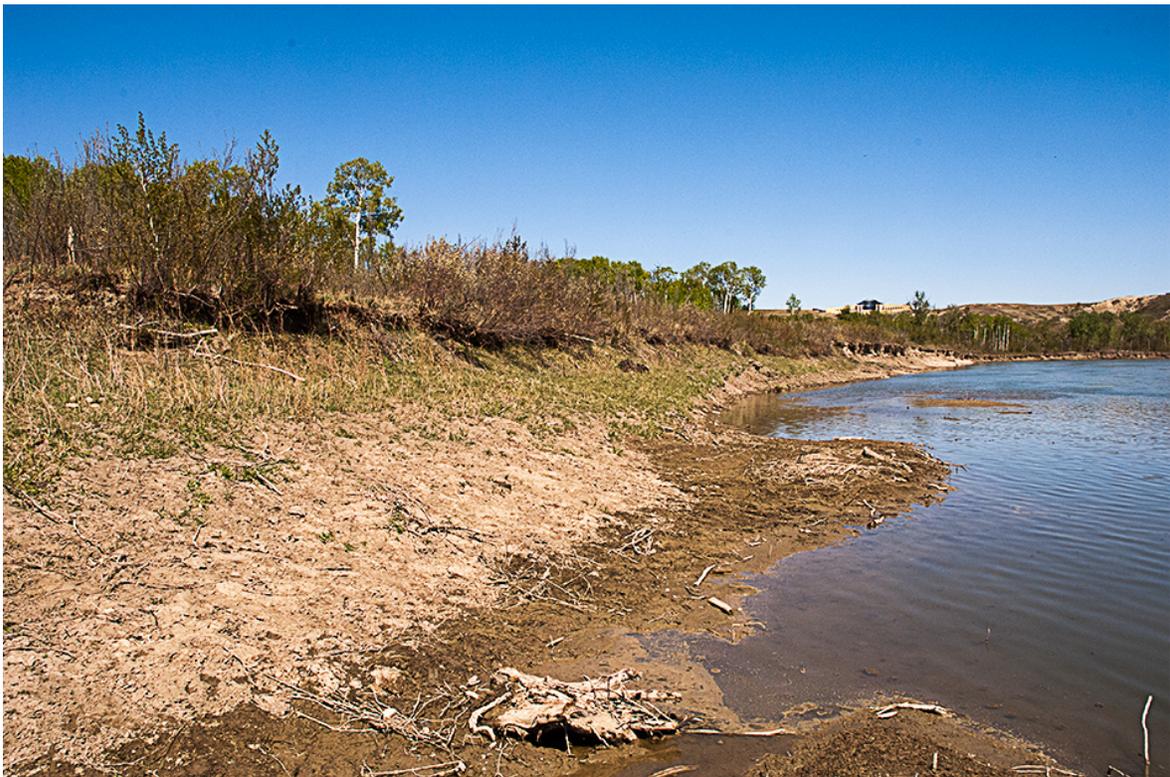
Plate 2. Looking east along the cutbank from the western boundary of BCHP (20150519). Much of the cutbank is overgrown or inaccessible by foot. The BCHP interpretive centre is visible in the background.

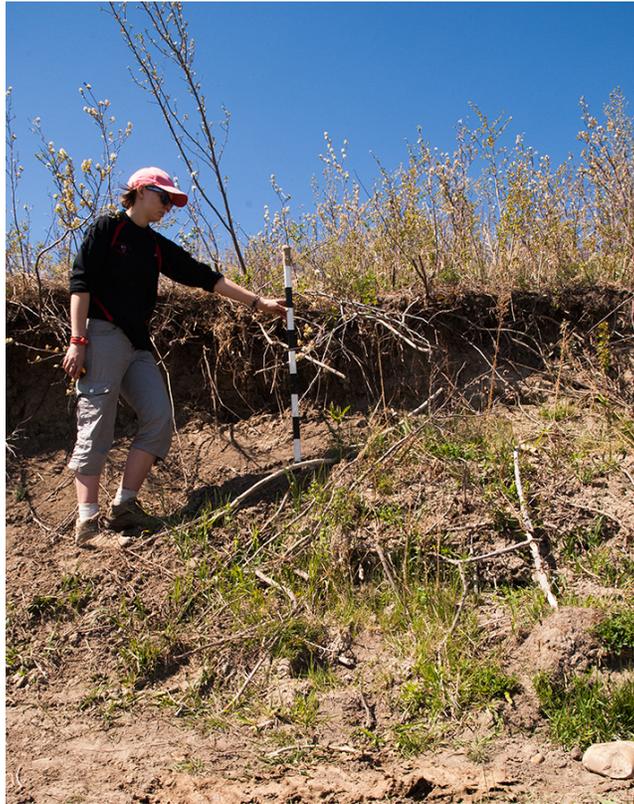
Findspot 1: 12U 368880 5626904 (Plate 3). A large bovid first phalanx and a large quartzite core were noted in the talus slope of the cutbank. No visible Ah_b was noted in the cutbank and no in situ artifacts were noted here.

Plate 3. Findspot 1. A single large bovid first phalanx and a large quartzite core were found in the collapsed cutbank material. The first phalanx was located at the base of the scale stick and the core is visible in the lower right area of the photograph.

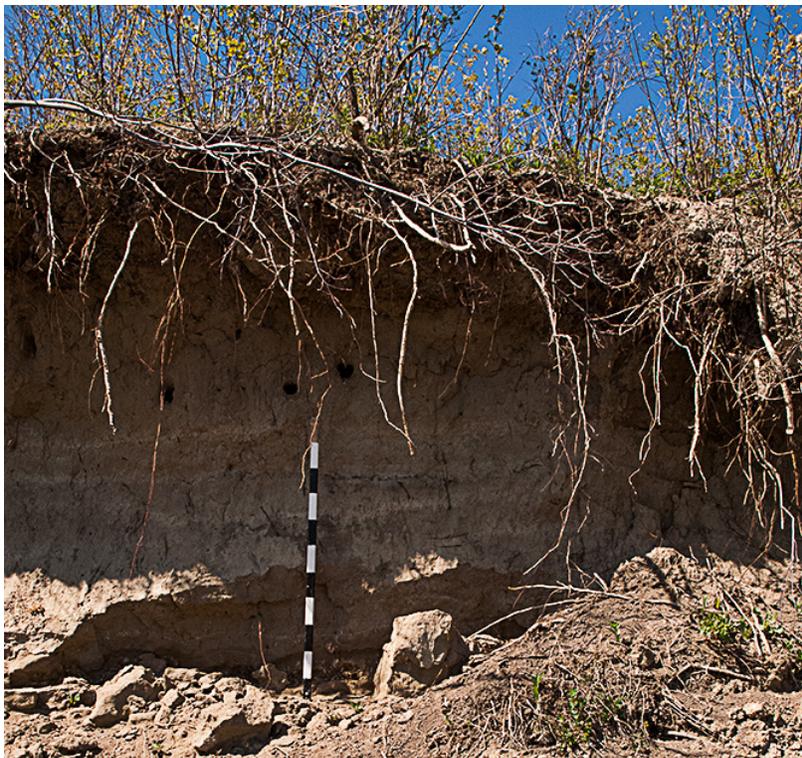
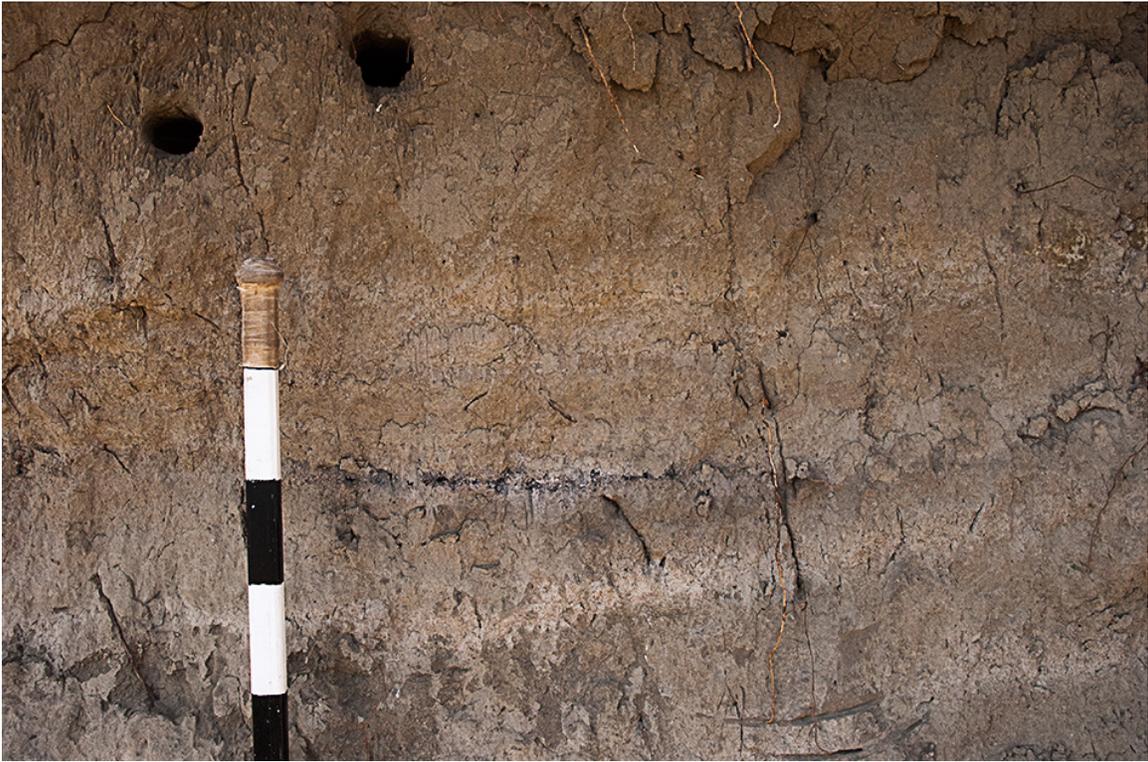
Findspot 3: 12U 368960 5626932 (Plates 4 and 5). An ash/charcoal lens was noted in the lower of two horizontal buried soil horizons. Samples were taken for future radiocarbon dating and paleobotanical analysis. A large mammal rib fragment was noted in the talus slope of the cutbank.

Plate 4. Findspot 3. A charcoal and ash lens (possible hearth) was noted in the cutbank at about 1 m below the present surface. A distant view showing the cutbank.

Plate 5. Findspot 3. Close view of the charcoal/ash lens.

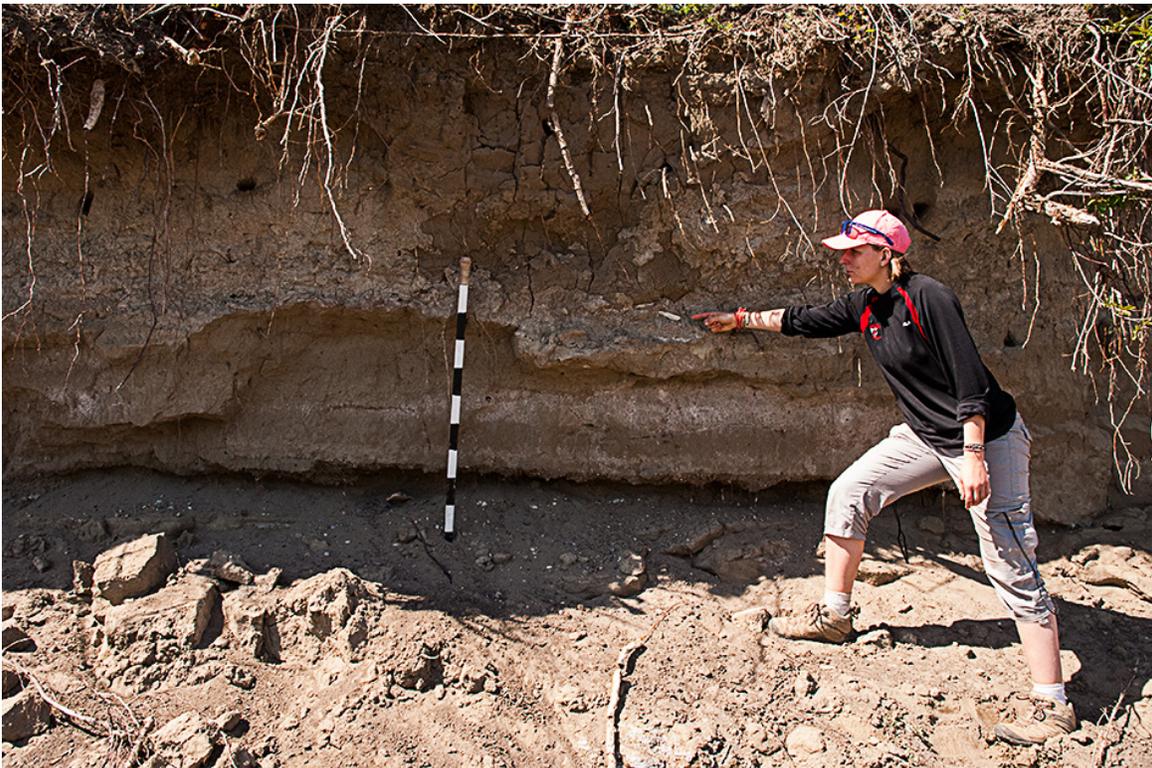
Findspot 5: 12U 369007 5626965 (Plate 6). A spirally fractured and possibly utilized large mammal bone fragment was noted in situ in the cutbank here at 1.15 m below the present surface—this specimen was collected. Also noted at 1.75 m below the present surface was a large mammal skull fragment in situ at the interface between the overlying silt deposits and the underlying sand and gravel deposits. This specimen may be paleontological and was collected. The hand-held GPS location recorded during 2015 places this findspot well off the cutbank on Figure 2. This is inaccurate as the materials were noted within the cutbank itself.

Plate 6. Findspot 5. Two bone fragments were noted in the cutbank, one at 1.15 m below surface (indicated by Tatyanna Ewald's pointing finger and the second at the interface between the sandy, pebbly stratum immediately below overlying silty deposits (ca. 1.75 m bs immediately left of the scale stick).

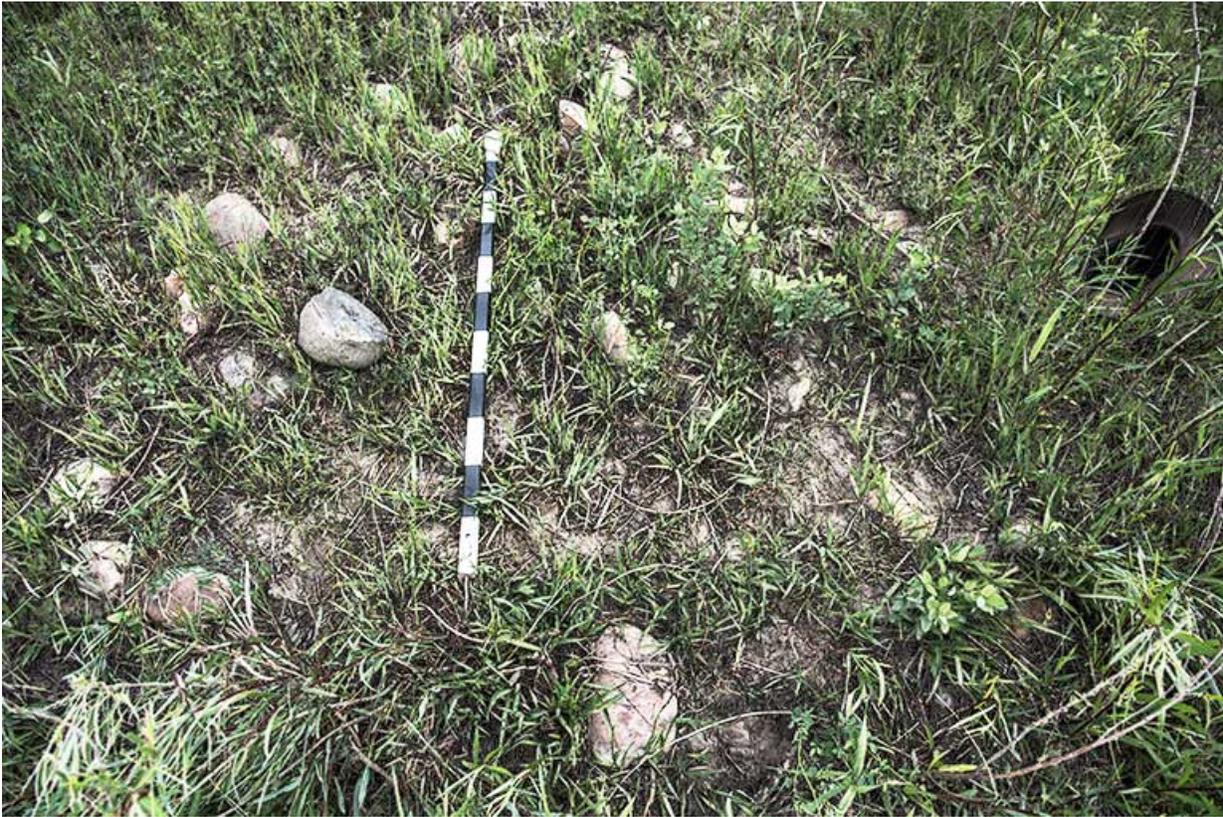
Findspot 8: 12U 368827 5626880 (Plate 7). A small stone circle about 1.25 m in diameter with associated firebroken rock and quartzite cores. The circle rests on the surface of a collapsed cutbank.

Plate 7. Findspot 8. A circular arrangement of cobbles with associated FBR and quartzite cores on the collapsed surface of the cutbank.

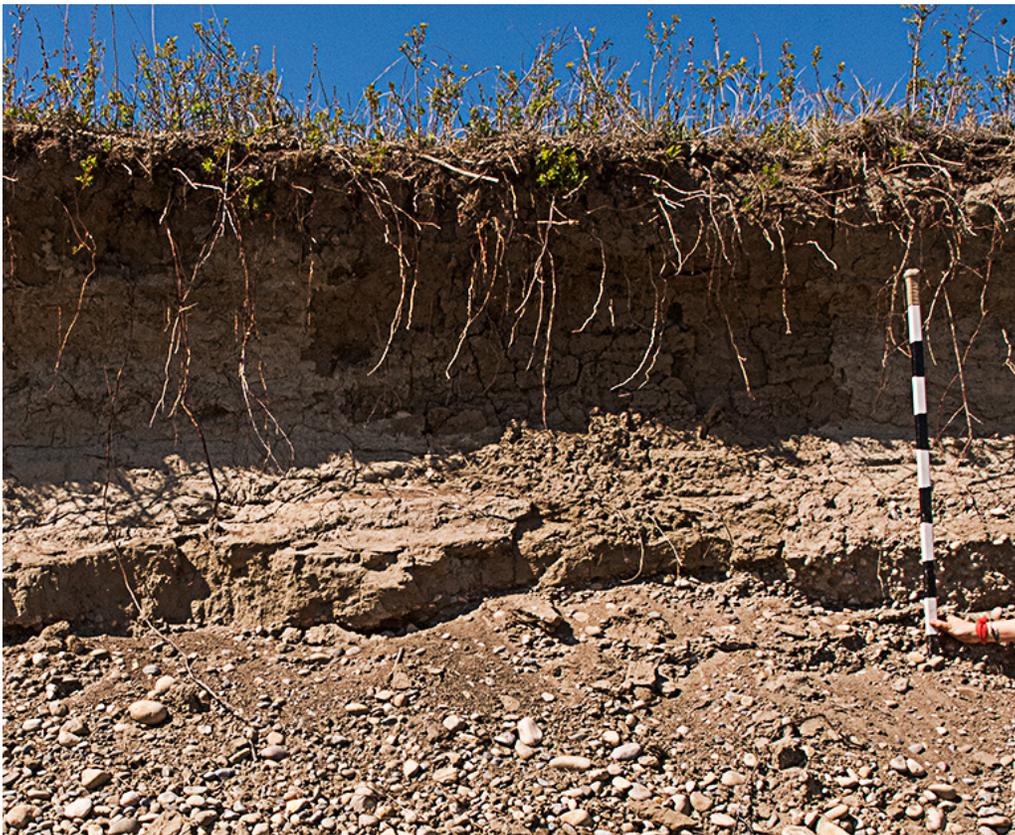
Three large pit-shaped soil changes were noted in the cut bank wall, as well (Plate 8). These soil features occur at 5 m intervals and are about 1.5 m by 1 m in horizontal and vertical extent respectively.

Plate 8. One of a series of three patterned matrix changes in the cutbank at approximately 5 metre intervals.
