Assessment of 2013 Flood Damage to Historic Resources
at Blackfoot Crossing Historical Park: Phase 1

University of Calgary
July, 2015

Executive Summary

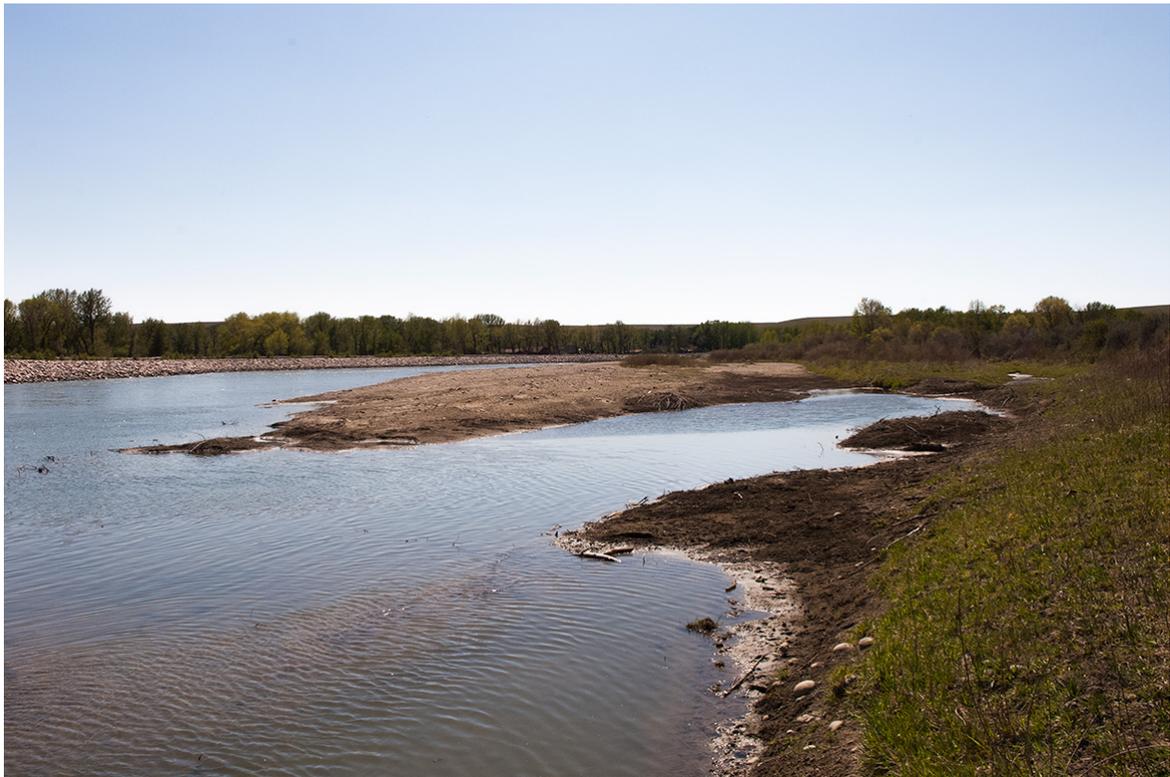
A visual inspection of those areas of the Bow River cutbank accessible by foot was initiated and completed on 19 May, 2015. The survey was initiated at 12U 0368826 5626877 and terminated at 12U 0369131 5626974 (Figure 2). Much of the cutbank is overgrown with very poor surface visibility (Plates 1 and 2). Eight findspots were noted along the cutbank and their locations were recorded using a hand-held GPS device; (error factor ranged between 5 and 8 m). Much of the cutbank in this area continues to be actively eroded.

Plate 1. Bow River looking west near western boundary of Blackfoot Crossing Historical Park (20150519). Note the low river level.
